# Carbon Trust “Low Carbon Buildings Accelerator”: Design and actual energy use for refurbishment projects

# Project 1: High Street Bank Branch

## Project 2: Leisure Centre

## Project 3: Police Headquarters

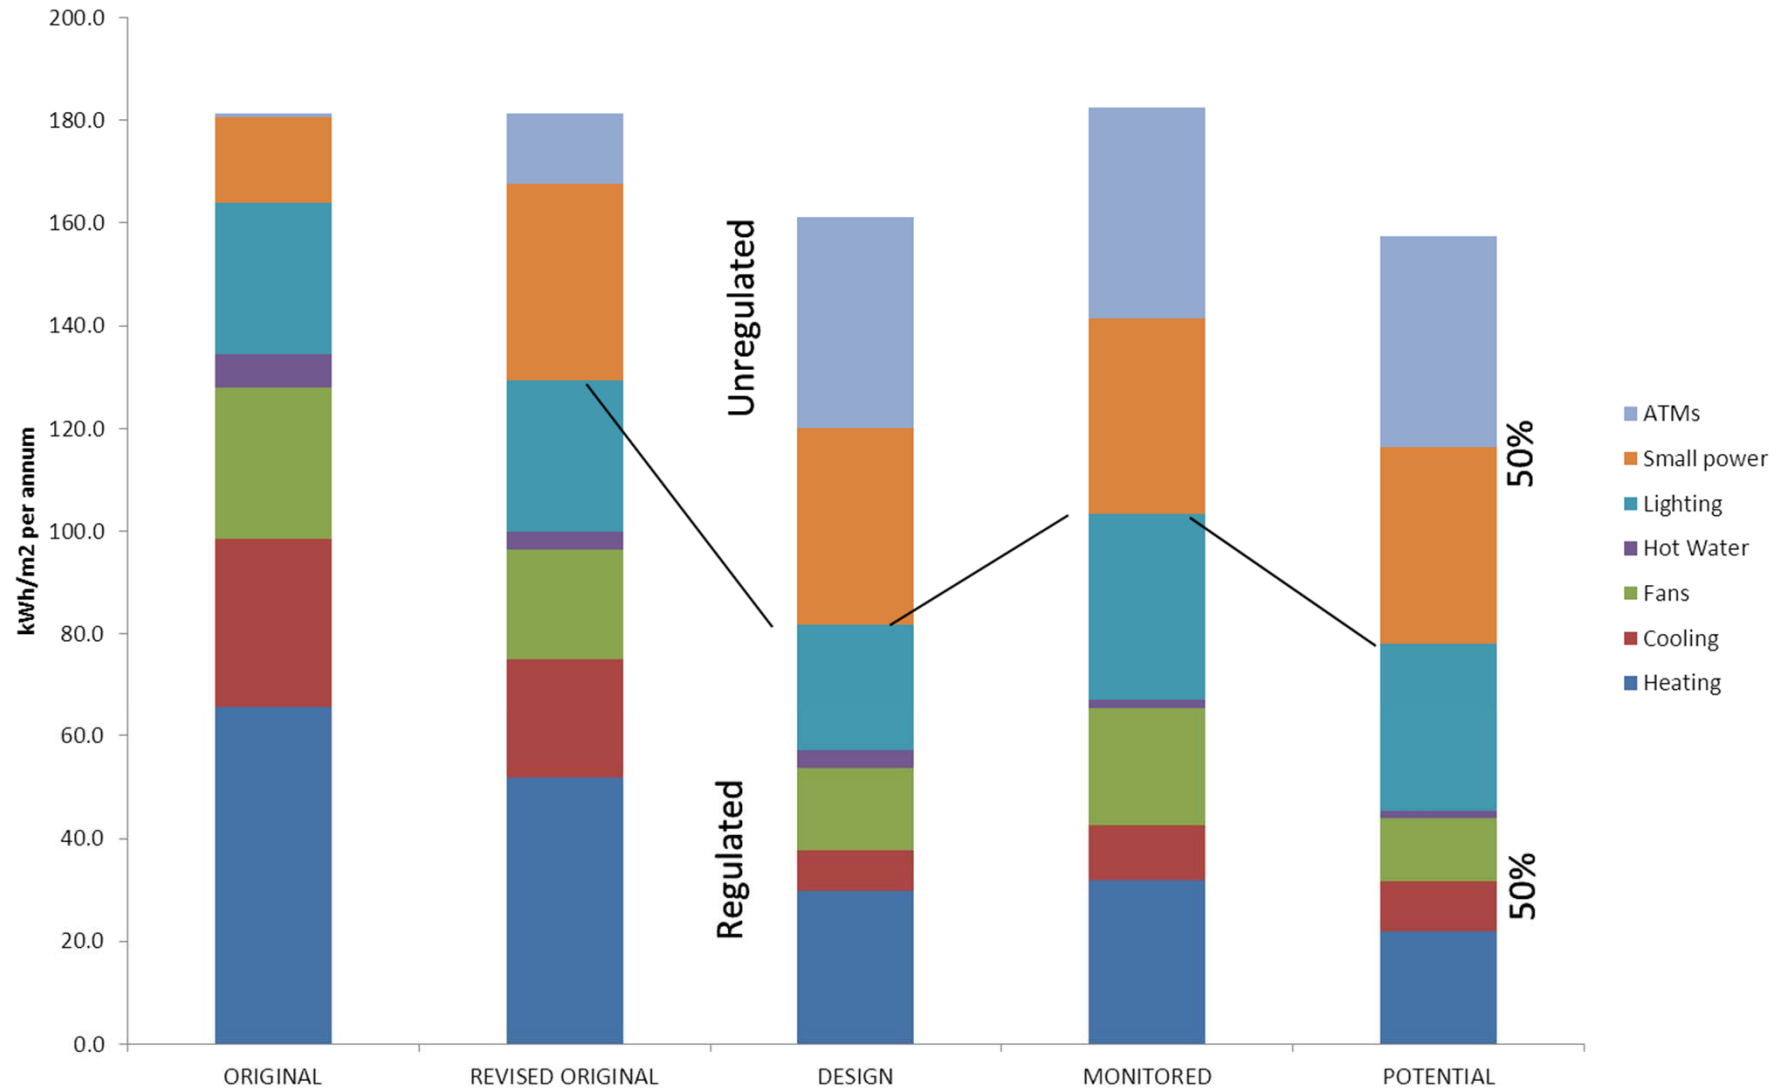
# TM22 Analysis of Energy Use

- Due to the small size and simple nature of the building a CIBSE TM22 modelling approach was used throughout
- This proved to be a very robust method of modelling the energy performance of the building throughout the various stages of the project
- As there is no variable flow or modulating control on site it was possible to accurately establish the energy consumption based on “on” and “off” time schedules and rated loads
- Activity logs were programmed into the BMS to record the operation of the presence detectors that control the lighting and heating in the intermittently occupied areas
- This information enable the TM22 model to accurately calculate the energy consumption of these areas

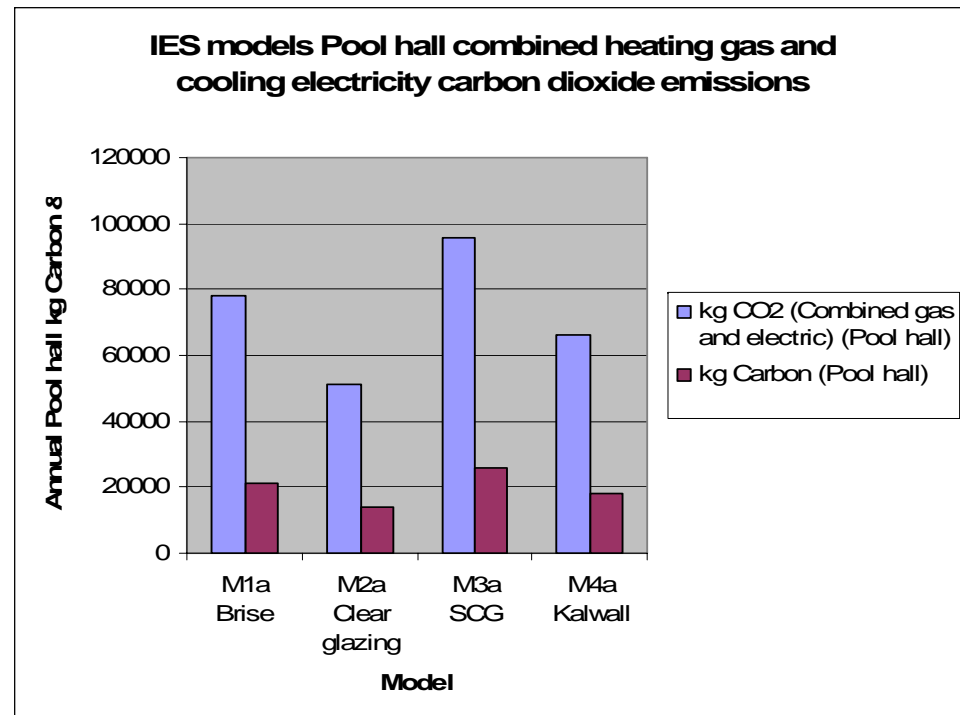
# Pool Hall facade modelling

## 4 options modelled

1. Brise soleil (BS) with clear glazing
2. No BS, clear glazing
3. No BS, solar control glazing
4. Kalwall insulation

The use of Option 2 shown as best as can be made to make use of solar gain to maintain the pool hall conditions.

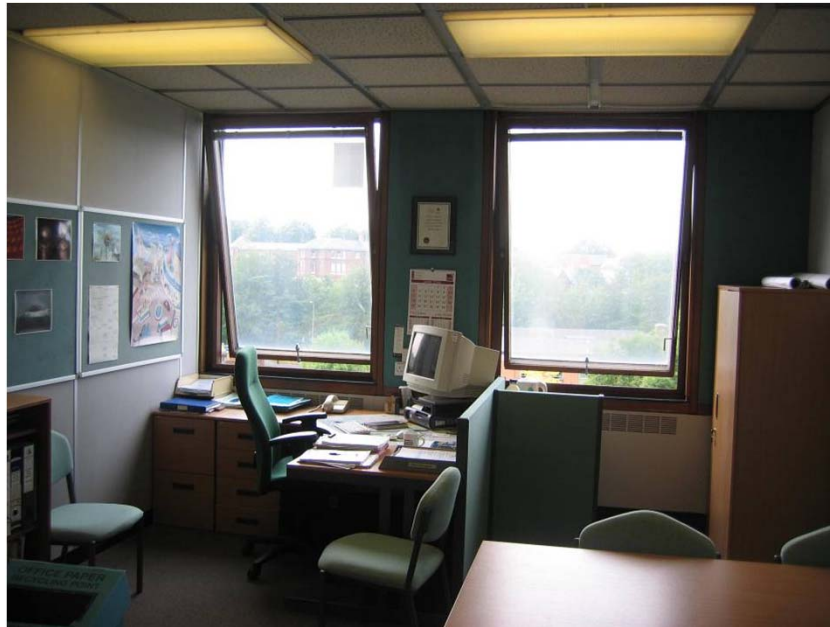
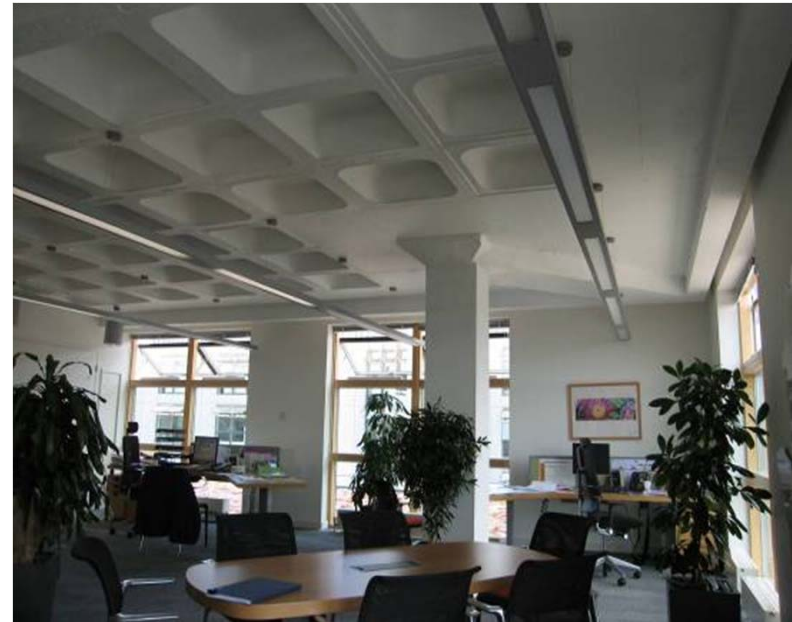
# Before and After

- “Deep” refurbishment
- Complete removal of the original building envelope down to the structural concrete frame
- Replacement of all building fabric
- Construction of a new ground floor on what was the top deck of the car park
- Complete renewal of all services

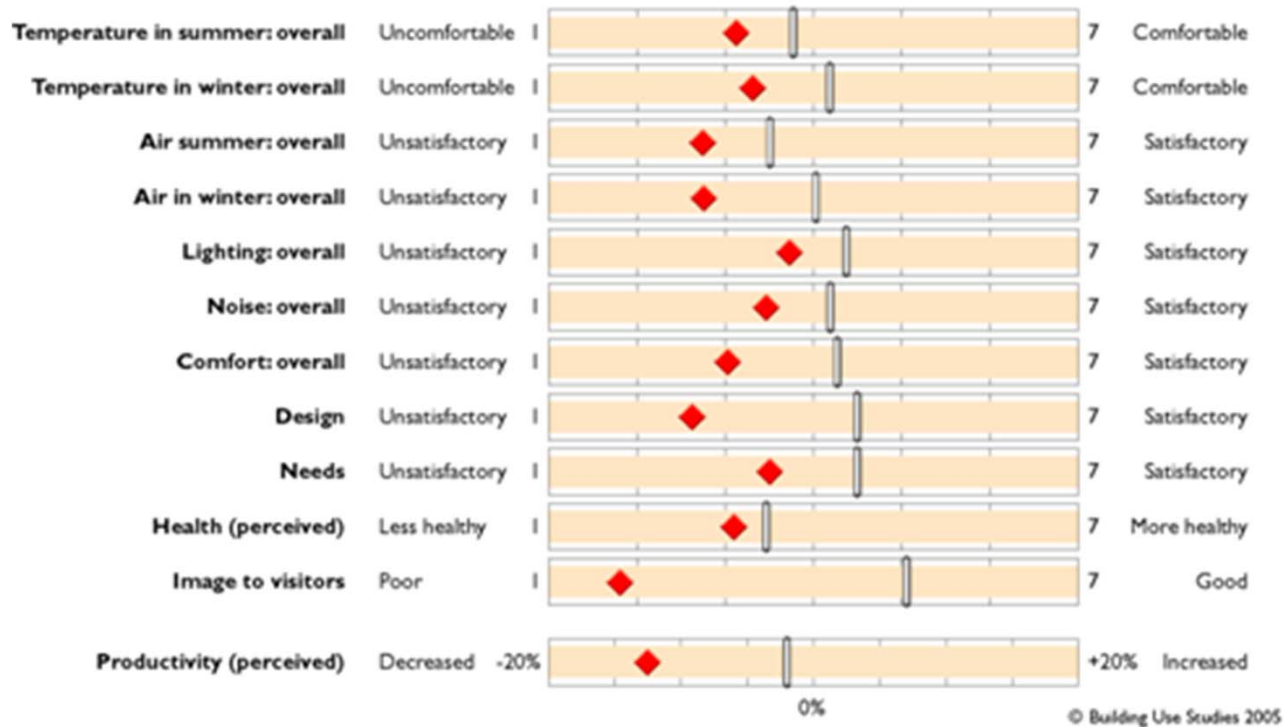
Ashburton Court 2006 survey

Green triangles represent mean values significantly better or higher than both the benchmark and scale midpoint. Amber circles are mean values no different from benchmark. Red diamonds are mean values worse or lower than benchmark and scale midpoint. The UK benchmarks are represented by the white line through each variable.

Be careful to read the directions of the scales and the scale labels.
